Annual Environmental Report

2024

Edgeworthstown

D0098-01

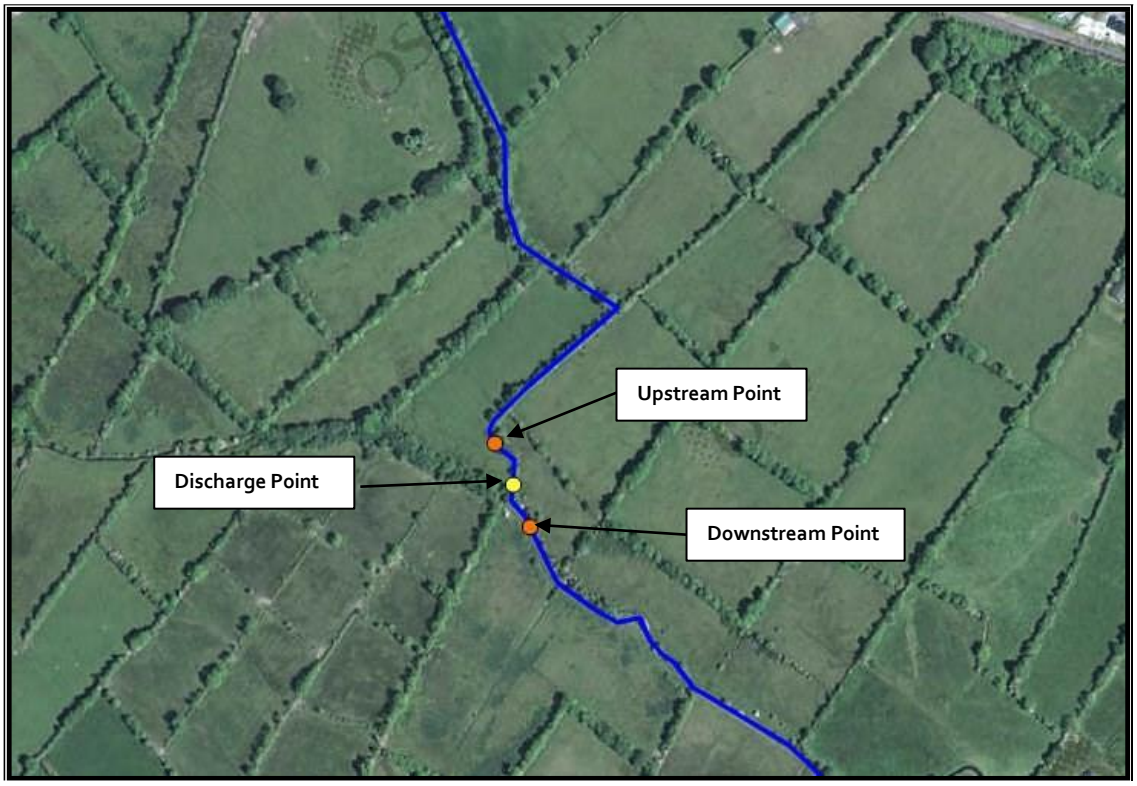
Figure 1 – Location of Sampling Points on the River Black

Biological water quality assessment was carried out at two separate locations on the River Black, both upstream and downstream of the effluent discharge point. These locations are summarised in Table 1 and illustrated in Figure 1.
