Greater Dublin Drainage

Alternative Sites Assessment - Phase Two Sites Assessment and Route Selection Report

Cultural Heritage

May 2012

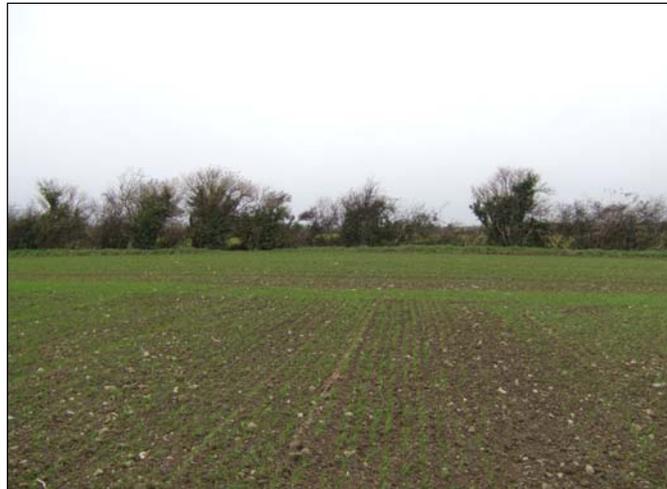
Plate 6.1 – Site of CH 38 (probable ring ditch), facing west

CH 38, 39, 40 and 41 were inspected in order to discern whether there were any upstanding remains and the topographic location of the sites. No upstanding remains were identified at CH 38, which is under arable crop. However, the site of the possible ring ditch occupied an area of higher ground (Plate 6.1), which overlooks the lower ground to the north. This area is characterised by the flood plain associated with the River Broadmeadow. It is not unusual to find prehistoric burial features, such as ring ditches in close proximity to water courses.

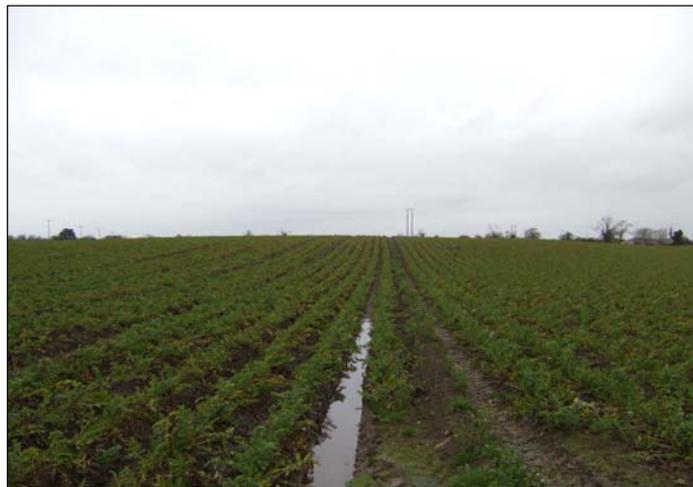
Plate 6.2 – Site of CH 39 (possible ringfort) on high ground, facing WNW

Both the sites of CH 39 and CH 40 were found to occupy a ridge of higher ground, which again overlooks the River Broadmeadow to the north (Plate 6.2, 6.3). Both the sites are linked by this ridge and may be contemporary. Whilst no above ground features could be identified, the location of these features on a ridge makes it likely that they are indeed early medieval settlement sites. Prior to post medieval drainage improvements in the area it is likely that the landscape to the north was characterised by marshy ground, meaning that both CH 39 and 40 would have been safe from flooding but close to the water course for travelling; close to a renewable food source and within 1km of the major early medieval settlement at CH 47. In addition, the early medieval field system, which is located c. 160m to the north-west, also occupies higher ground.

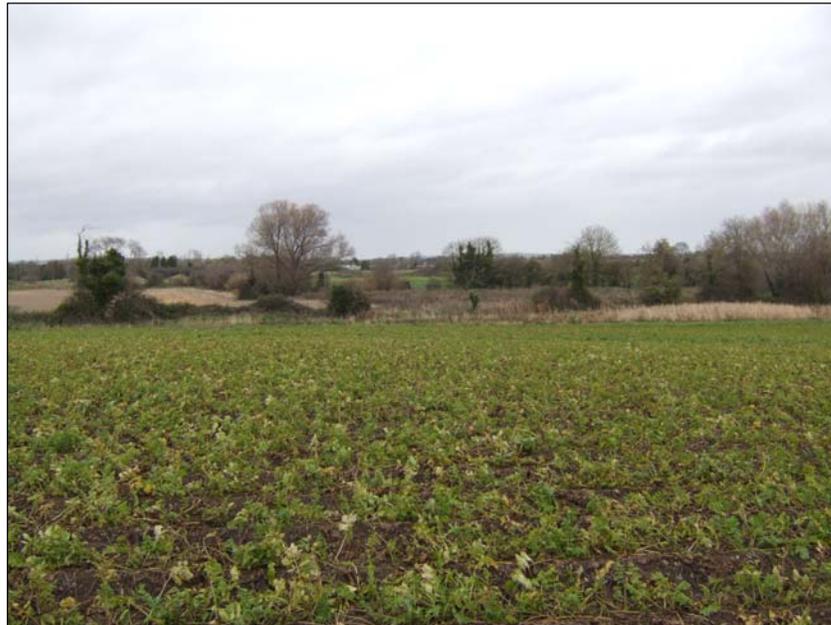
Plate 6.3 – A view NNE from the site of CH 40 (possible ringfort), over River Broadmeadow flood plain
